Harvest Inspection Services of New Hampshire

DATE OF INSPECTION: 03/07/2005.

INSPECTION LOCATION: 3 Damascus Rd.

CITY/STATE/ZIP: Wilton NH.

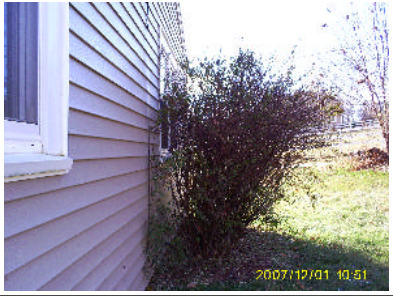
DRIVEWAY	Asphalt. Surface deterioration.
WALKWAYS	Stone.
SIDING	Wood. Vegetation should be trimmed away from the structure. Peeling paint.

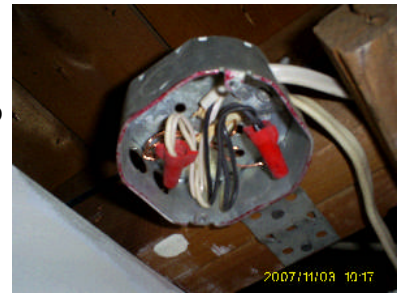
Open junction boxes/open splices were noted. This is a safety concern. Whenever an electric wire is cut and re-connected, the "splice" should be encased in a covered junction box to prevent shocks and separation of the splice. Client is advised to consult with a qualified electrician for repairs.

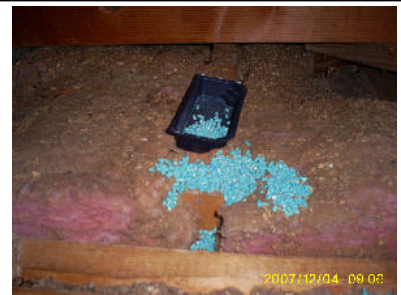
Pests

Bait and/or traps observed.

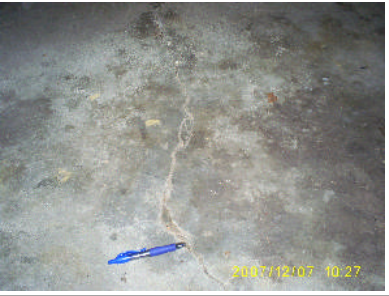
Access	Interior Location at kitchen. Exterior location at, bulkhead.	
Stairs	Cracked steps. Suggest repair for safety.	
Floors	Poured Concrete. Water stains at floor indicate water seepage. Common cracks noted. Suggest sealing.	
Walls	Poured concrete. Common cracks noted. Efflorescence noted, sign of potential water entry.

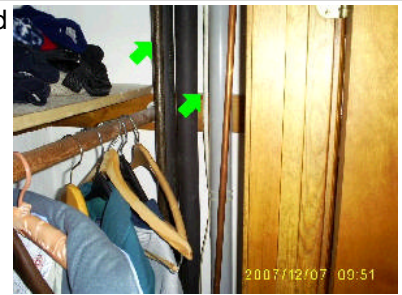
Serviceable. Wood.
Serviceable.
Serviceable.
Serviceable. Thermopane.
Serviceable. Fixed.
Serviceable.
Exposed wiring or plumbing should be encased in protective covering for safety.

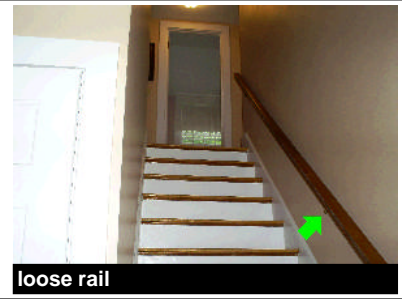
Loose railing. Recommend repair for safety.
