Harvest Inspection Services of New Hampshire

DATE OF INSPECTION: 03/07/2005.

INSPECTION LOCATION: 3 Damascus Rd.

CITY/STATE/ZIP: Wilton NH.

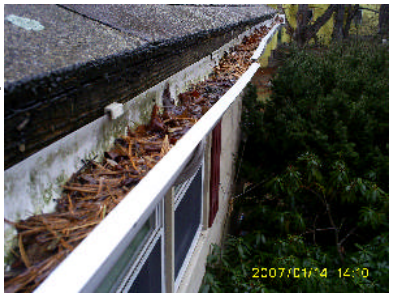
TRIM	Wood. Peeling paint. Crack/broken.
WINDOW FRAME	Wood. Reglazing required at loose or missing glazing . Periodic maintenance should be expected to maintain integrity of glazing at windows.
ELECTRICAL	No Ground Fault Interrupters (GFI's). Suggest client consider upgrading to GFI's at all receptacles near water sources, such as the kitchen, bathrooms, garage, and at exterior outlets to ensure safety. All electrical upgrades should be performed by a qualified electrician.
GUTTERS& DOWNSPOUTS	Gutters are leaking. Recommend repair of leak. Suggest gutters be cleaned out as part of normal maintenance to ensure proper drainage.

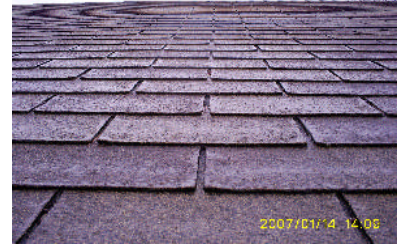
Roof was walked upon.
	Sloped. 3-tab.
	Appears intact.
	Roof shows normal wear for its age and type. No damaged, deteriorated, or missing roofing materials were noted; appears to be in serviceable condition.

Suggest re-sealing all through roof vents and projections as part of routine maintenance.

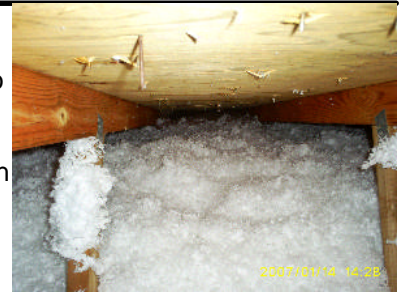
Attic access located at Master Bedroom. Closet. Hatch. Limited access. Entering attics that are heavily insulated can cause damage to the insulation and attic framing. Attics with deep insulation cannot be safely accessed due to limited visibility of the framing members upon which the inspector must walk. In such cases, the attic is only partially accessed, thereby, limiting the review of the attic to the view from the hatch area only.

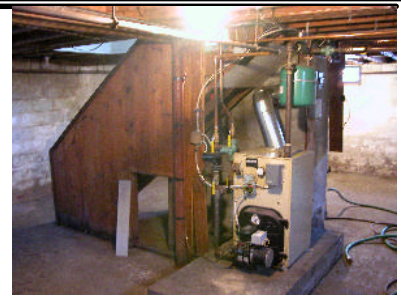
Location: basement. Manufacturer is Weil Mclain
 Approximate year of manufacturing: 1989
 System Type: Forced hot water boiler. Energy Source: Oil. Oil shut off and electric disconnect provided.

Firebox/burner, Serviceable. Temperature pressure relief valve with drain line installed as a safety feature.

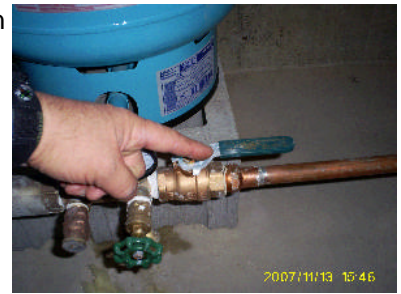
Public Water supply. Main shut off is located in the basement.
